# **COAST DEVELOPMENT AUTHORITY**

## **KENYA CLIMATE CHANGE ADAPTATION PROGRAMME**

### **Mangrove Rehabilitation in Vanga & Gazi**

*December 2017*

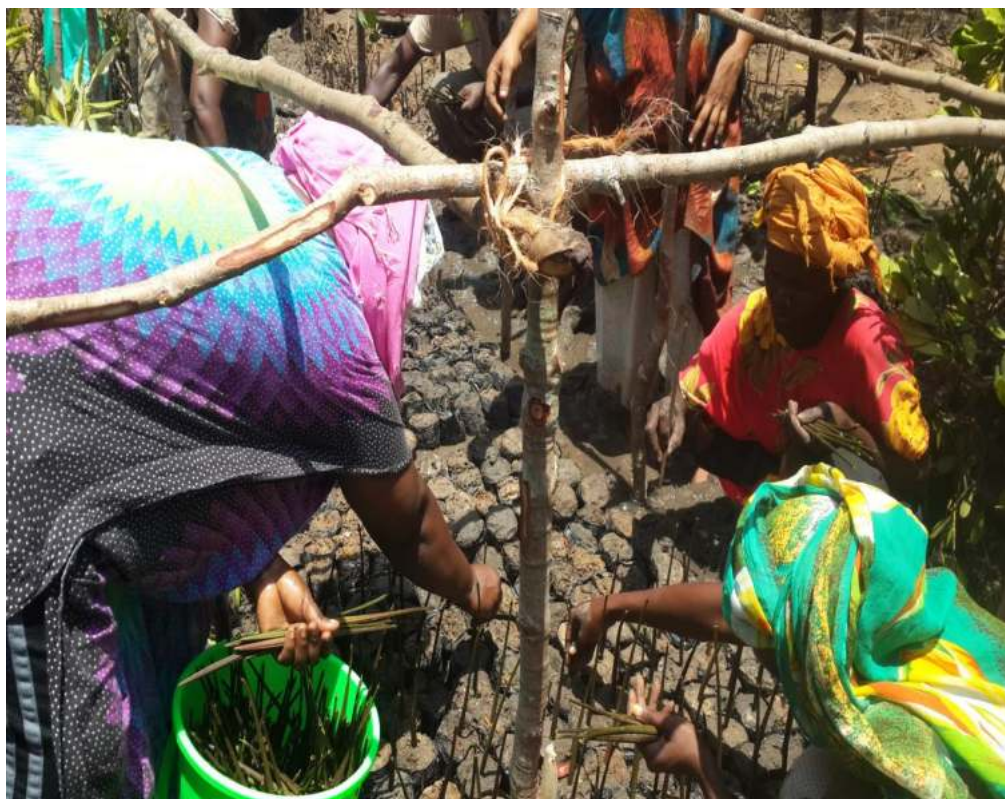
Sowing *Ceriops tagal* seeds in Makongeni site

- Site selection; this should be near the planting site for ease of transfer during the planting so that the seedlings are not stressed.
- Selection of suitable soils for filling the potting bags; the soils should be the black sticky soils and not the sandy soils as these lack nutrients to sustain the seedling. The appropriate size for potting bags should be size 12.5cmx 20cm and 15cmx30cm depending on the species characteristics. The pots are arranged in 100s for ease of counting and maintenance of the nursery.

- Selection of seeds/sorting-seeds should be mature and healthy without deformation. *Avicennia sp* seeds should be soaked in fresh water overnight before sowing the seeds in the nursery. Mature mangrove seeds have developed roots.

- Sowing of seeds; bury the rooting part only as burying the stem causes rotting of the seeds.
- Putting up the shade; the nursery should be under a shade made of *makuti* to protect the seedlings against the sun.

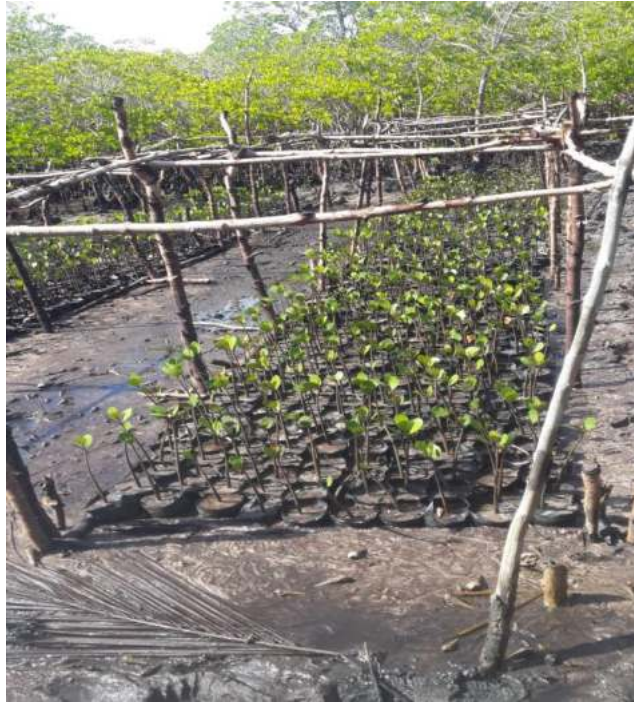
Baraka Conservation Women group *Ceriops tagal* nursery

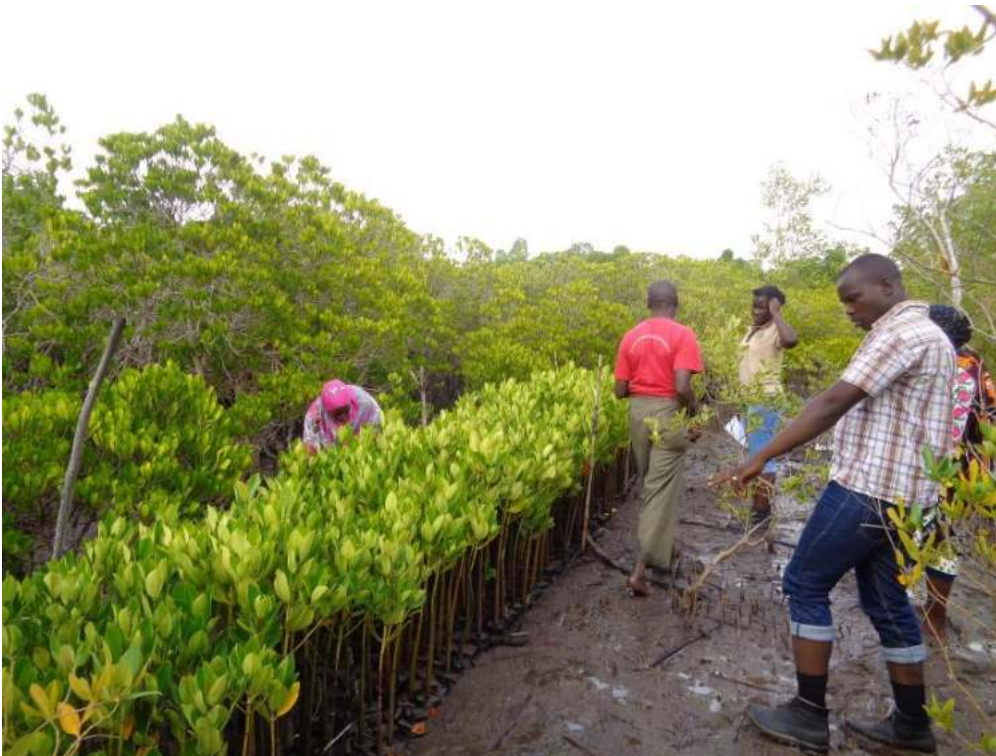
*Seedling inspection at Makongeni, Gazi*

carried out from 6<sup>th</sup> to 8<sup>th</sup> September 2016 by a team from CDA, KMFRI, KFS and the community. Two sets of nursery beds were identified in Vanga, one at Baazo and the other at Vingobani (both in Jimbo). However, not all the seedlings were deemed fit for planting as they had a number of defects including partial defoliation, some parts of the stems eaten by crabs and partial wilting. Some of the seedlings had overstayed in the nurseries and had developed roots pushing through the potting bags on the ground.

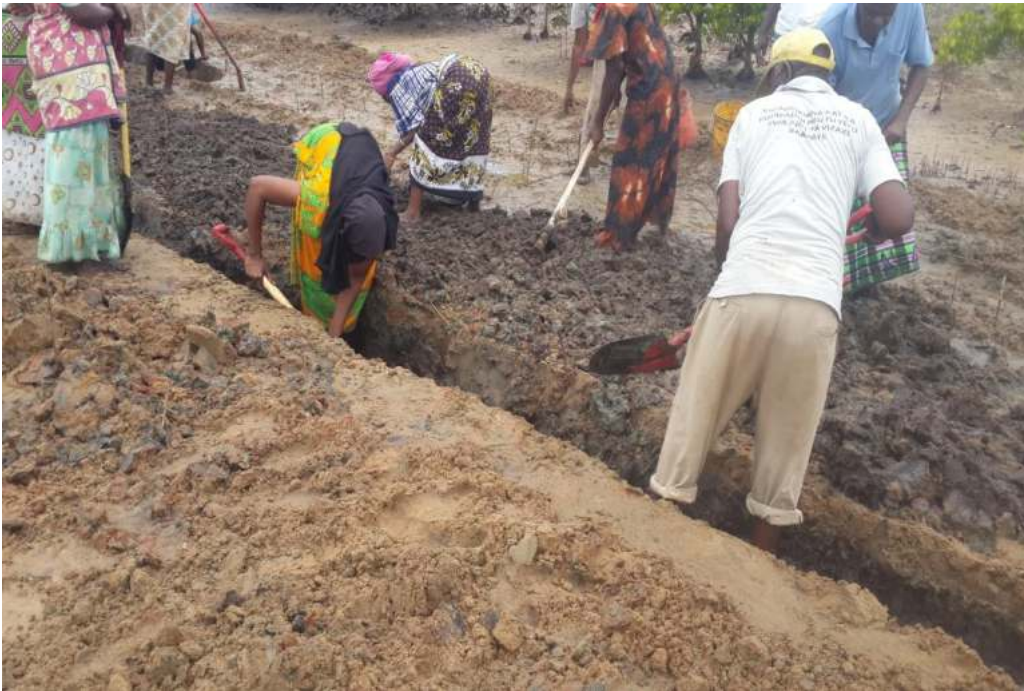
*Site preparation at Jimbo in Vanga*

This refers to the activities carried out on sites to be rehabilitated as some areas have been heavily silted and some eroded. Due to the technicality of planting the mangrove species identified there was need to undertake pre-planting preparations to increase chances of survival for planted seedlings. A methodology known as *hydrological modification* was recommended by the mangrove ecologist as the best measure to do the planting exercise in the tidal deserts. The exercise involved preparing tunnels to drain water during high tide. Due to siltation, the top layer is exfoliated to expose the dark clay soils which are suitable for mangrove planting. The activity was done from 25<sup>th</sup> to 29<sup>th</sup> April 2017 for Jimbo Environmental Group in Vanga and Baraka Conservation Women group in Makongeni, Gazi sites.

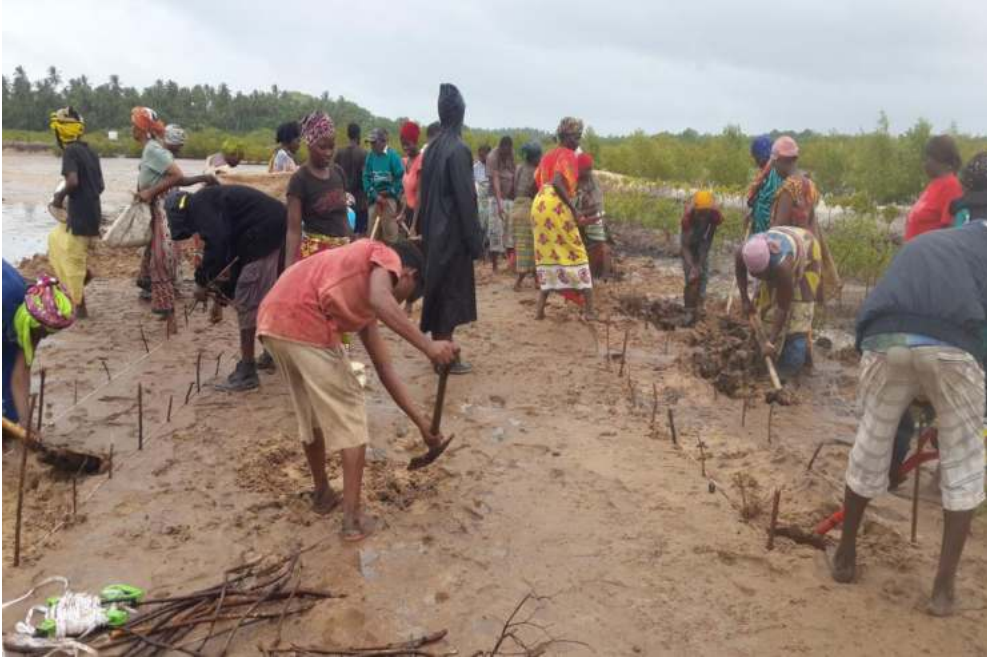
*Site preparation at Makongeni Gazi*

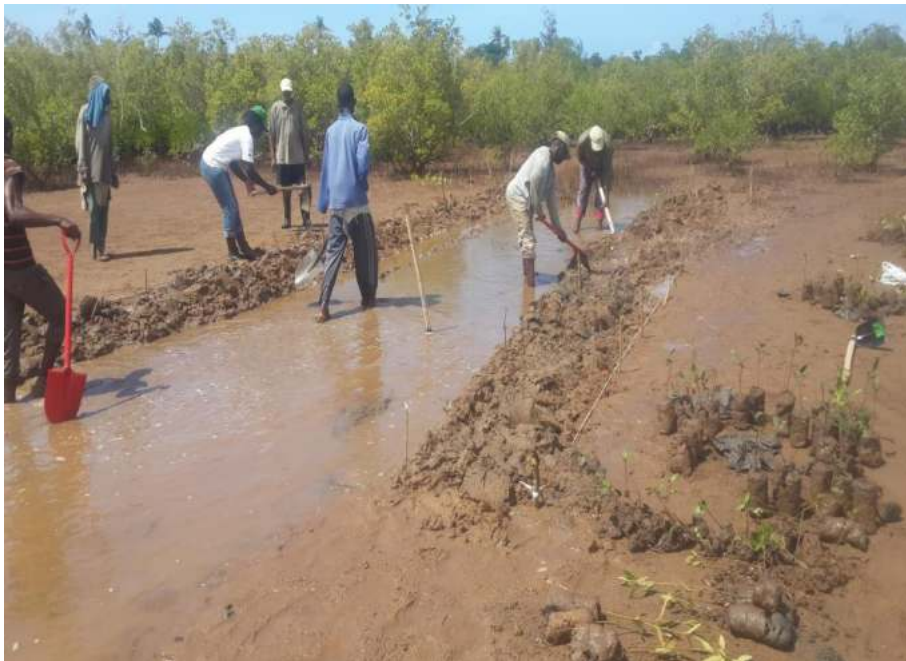
*Preparing the Mwagugu site before planting*
